SEALY ENGINEERING

FOUNDATION INSPECTION REPORT

The residence inspected was located at _____, Houston, Texas. The client for this inspection was _____. The residence was not occupied and the client was present.

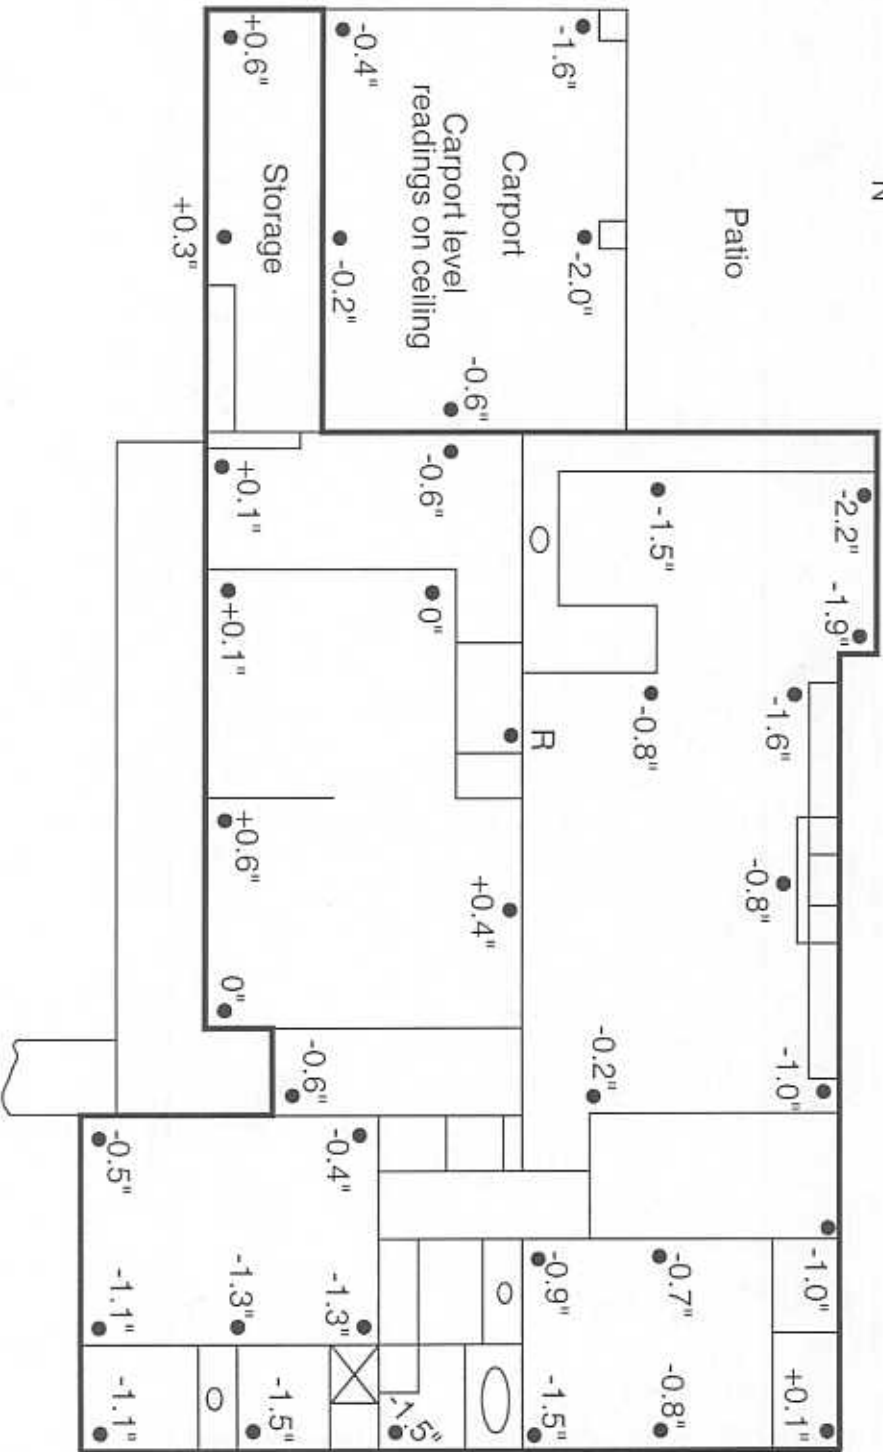
The foundation of this residence was observed to have incurred deflections which caused damage to other structural components. The level deviations were measured using an electronic version of a waterlevel, either a Stanley Compulevel or a Zipllevel by Technidea in this case, and the results have been superimposed upon an attached sketch. Compensation was made for variations in the height of the floor coverings so that the measurements shown should reflect the relative height of the top of the concrete slab. To better understand the significance of these measurements, contours of equal height were drawn and these are shown in another attached sketch. From these sketches, it can be seen that the slab was measured to be level within approximately 2.8" from the high point to the low point. Based upon my experience, this is more than would normally be expected for a house of this size, with a more typical average usually being in the range of about 1.5". That also is the recommended slab construction tolerance given by the American Concrete Institute. The high area was located at the front of the house around the living room and utility room and the low areas were at the rear and on the northwest side of the bedroom wing. Brick cracks to about 3/8" in size were noted. The front and rear brick lines are straight and the northwest brick line along the bedrooms dips in the middle. The brick line at the front of the bedroom wing is straight but slopes downward to the north corner. Sheetrock cracks to about 1/8" were also seen, along with door misalignments to about 3/8". We observed no exposed slab reinforcement steel or honeycombing in the edge of the slab. Large cracks were not observed in the visible part of the foundation grade beam. Cosmetic slab corner cracks are present. As far as other cracks which may be present in the grade beam it should be understood that cracks can be extremely difficult to see and could possibly be detected by the client at some time after the inspection has been completed. Since cracking is a normal property of brittle materials such as concrete, neither the author nor Sealy Engineering assume any responsibility whatsoever should cracks be found which were not mentioned. It is our opinion that other indications are more important in determining whether a house has a foundation problem since cracks may be present in slabs due to shrinkage or minor movements.

The drawing at the end of this report is provided to aid in determining the condition of the foundation. "R" on the drawing represents the reference point from which all other level readings are taken and it is arbitrary. Changes in floor coverings such as the transition from carpet to tile etc. are taken into consideration when taking level readings. Taking the largest positive reading and adding the largest negative reading will give the overall levelness of the structure. Generally, when new houses are finished, a certain amount of slope is built in. This slope is generally in the range of 1.5 inches for the average size house. Level readings are valuable not only as a diagnostic tool but can be used as a reference for any suspected foundation movement that may occur in the future. Readings can also verify the stability of a house. Please note that the scale of the drawings can change with faxing or copying of the original sketches.
