R & C INSPECTIONS CO.

PROPERTY INSPECTION REPORT

Report Identification

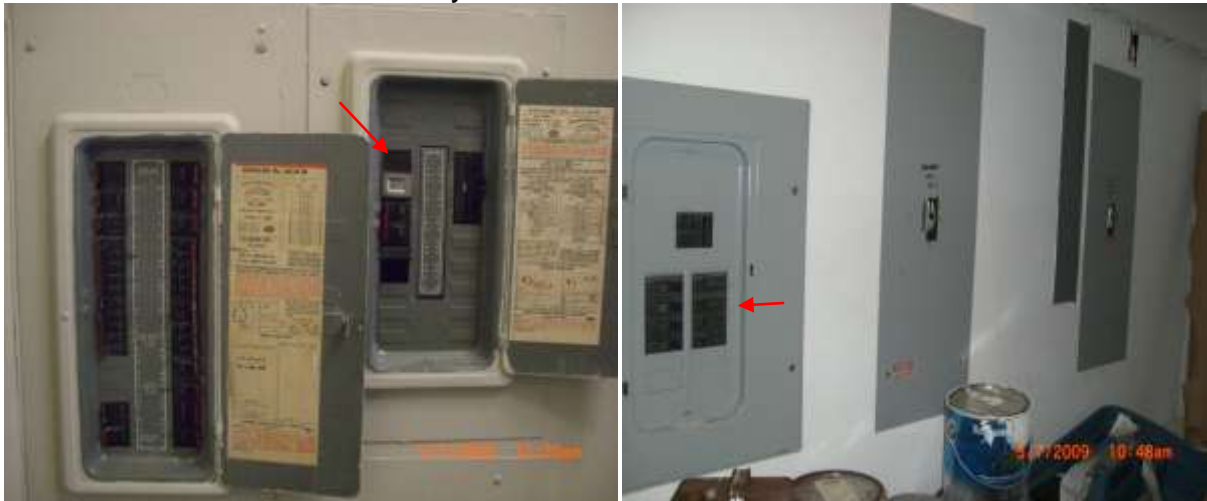
A. SERVICE ENTRANCE AND PANELS

Comments: 200 AMP & 125 AMP PANELS (Federal Pacific Electric & General Electric)

OBSERVATION OF SERVICE ENTRANCE AND PANELS NOTED THE FOLLOWING DEFICIENCY:

- 1. Missing Knockouts in Panel Box
- 2. Panel Box not Fully Labeled.

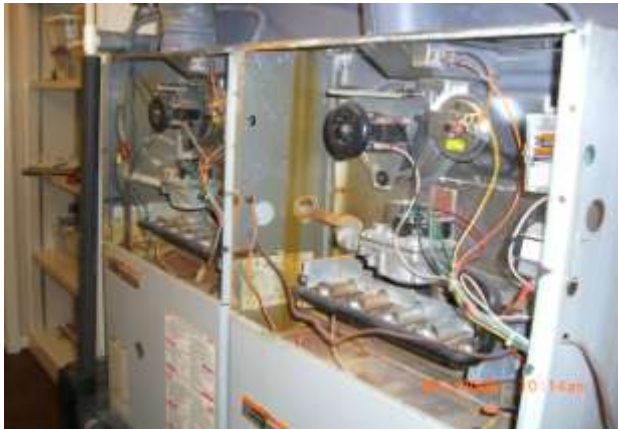
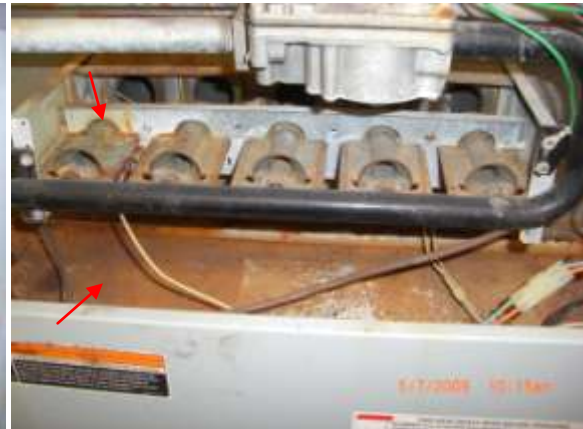
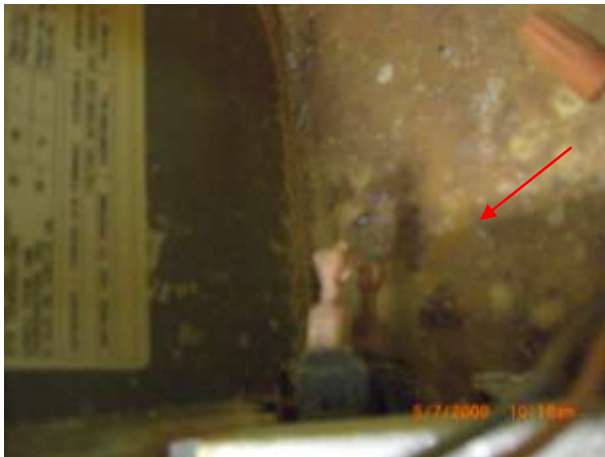
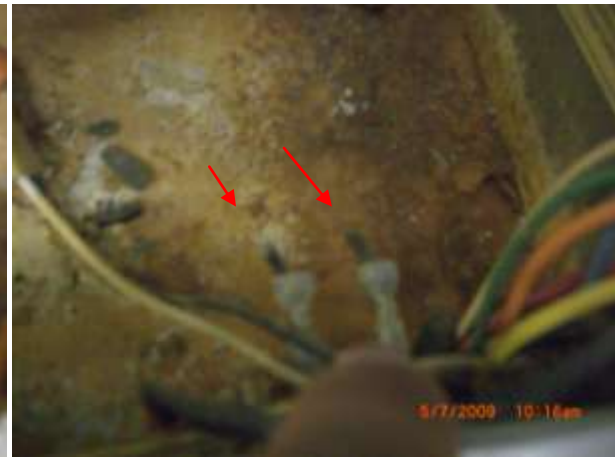
A. HEATING EQUIPMENT

Comments: UNIT 1 & 2) 110,000 BTU (Dual System) MFG. DATE 1999

NOTED THE FOLLOWING DEFICIENCY:

1. Rust & Scale build up in Units (Previous Primary Drain Line Leak) –Needs to be Cleaned & Exchangers Checked.
2. Both Safety Door Switches have been cut.

NOTE: VISUAL INSPECTION ONLY. HEAT EXCHANGER NOT COMPLETELY CHECKED FOR CRACKS OR HOLES, NO DISASSEMBLY OF EQUIPMENT IS PERFORMED AS A PART OF THIS INSPECTION.

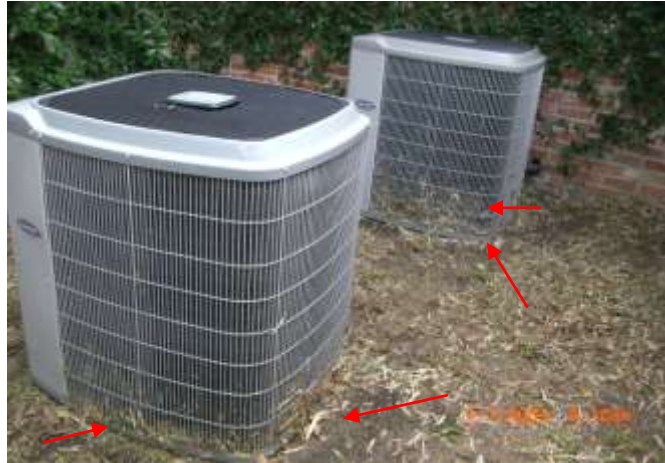
B. COOLING EQUIPMENT

Comments: UNIT 1) 5 TON MFG. DATE 2002

UNIT 2) 5 TON MFG. DATE 2000

NOTED THE FOLLOWING DEFICIENCY:

- 1. Both Units – No Electrical Disconnects.
- 2. Both Units – Clean Coils
- 3. Both Units – Raise Pads or Lower Soil Levels (Ponding)

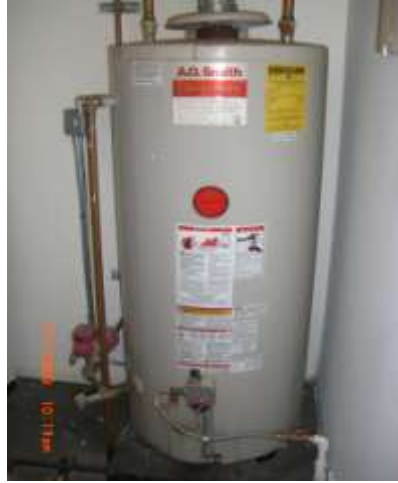
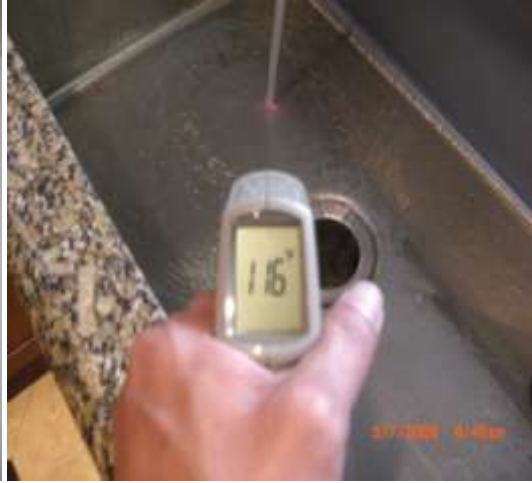
C. WATER HEATING EQUIPMENT (Report as in need of repair those conditions specifically listed as recognized hazards by TREC rules.)

Capacity: 75 GALLON UNIT MFG. DATE 1999

Comments. NO VISIBLE INDICATION OF LEAKS OR PROBLEMS AT THE TIME OF THIS INSPECTION.

REPCIRCULATING PUMP – NO VISIBLE INDICATION OF PROBLEMS.

WATER TEMPERATURE AT THE KITCHEN SINK IS 116 DEGREES.

NOTE: WATER TEMPERATURE SHOULD NOT EXCEED 120 DEGREES FOR SAFETY.

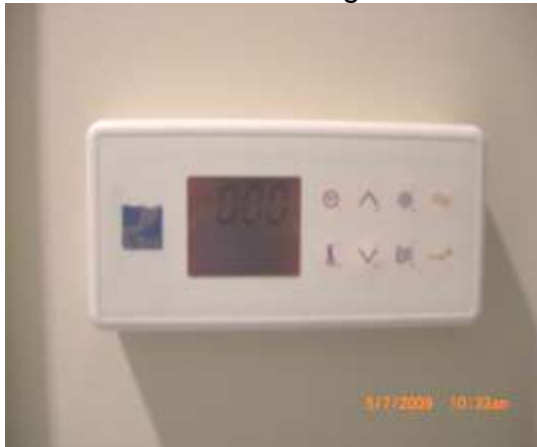
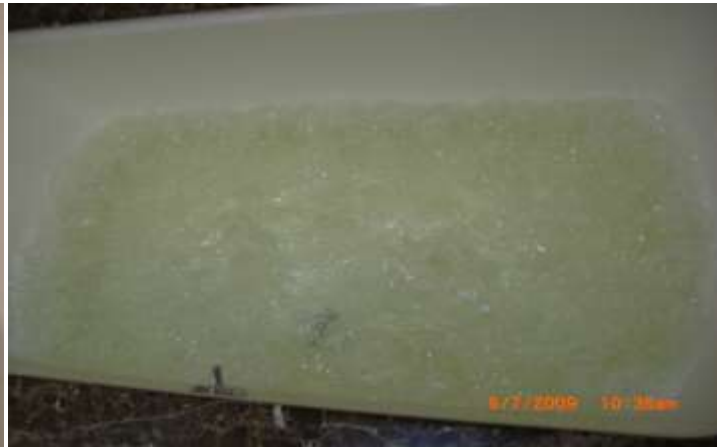
D. HYDRO-THERAPY EQUIPMENT

Comments: OPERATION OF UNIT APPEARS TO BE FUNCTIONING. NOTED THE FOLLOWING DEFICIENCY:

- 1. No Sign of G.F.C.I. Protection.

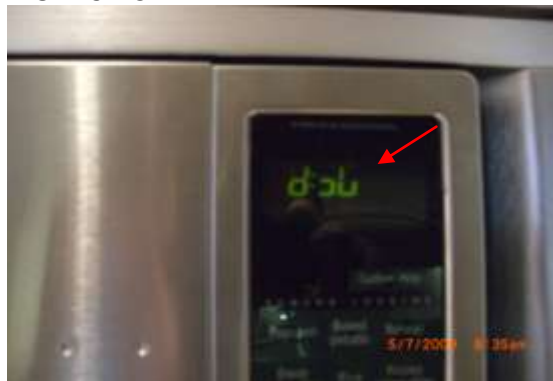
E. MICROWAVE COOKING EQUIPMENT

Comments: UNIT MFG. DATE 1999

NOTED THE FOLLOWING DEFICIENCY:

1. LED Display damaged.

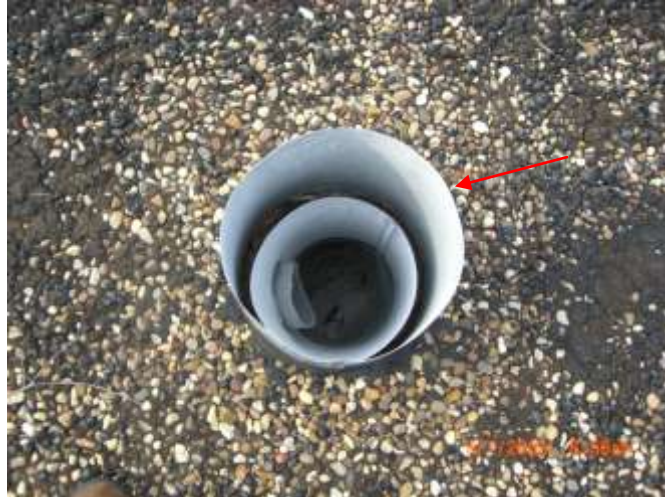
J. DRYER VENTS

Comments: NOTED THE FOLLOWING DEFICIENCY:

- 1. Vent Cover missing at Roof.
- 2. Lint collecting in Pipe – Need to be cleaned.

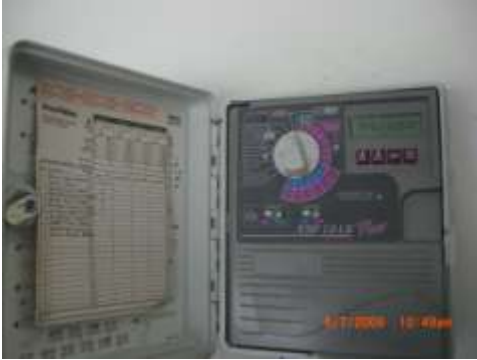
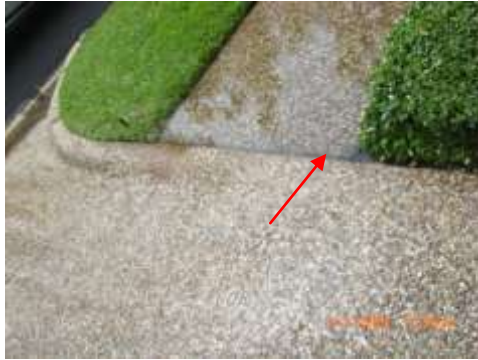
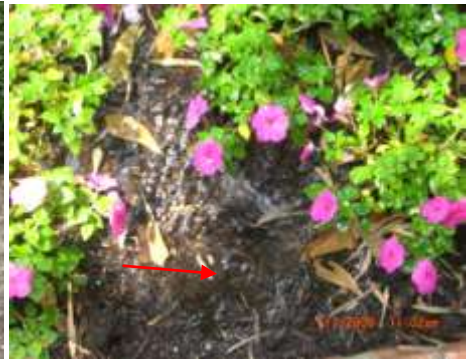
A. LAWN SPRINKLER SYSTEMS

Comments: CHECKED IN MANUAL MODE ONLY. 11 ZONES.

ALL ZONES RESPONDED TO TEST. NOTED THE FOLLOWING DEFICIENCY:

1. NO SIGN OF ANTI-SIPHON VALVE LOCATED.
2. Break in Lines at Zone 3 at Left Front by Sidewalk & 2 & 4 at Left Side House
3. Divert Water away from House.
