SEALY ENGINEERING

FOUNDATION INSPECTION REPORT

The residence inspected was located at _____, Houston, Texas. The client for this inspection was _____. The residence was not occupied and the client was present.

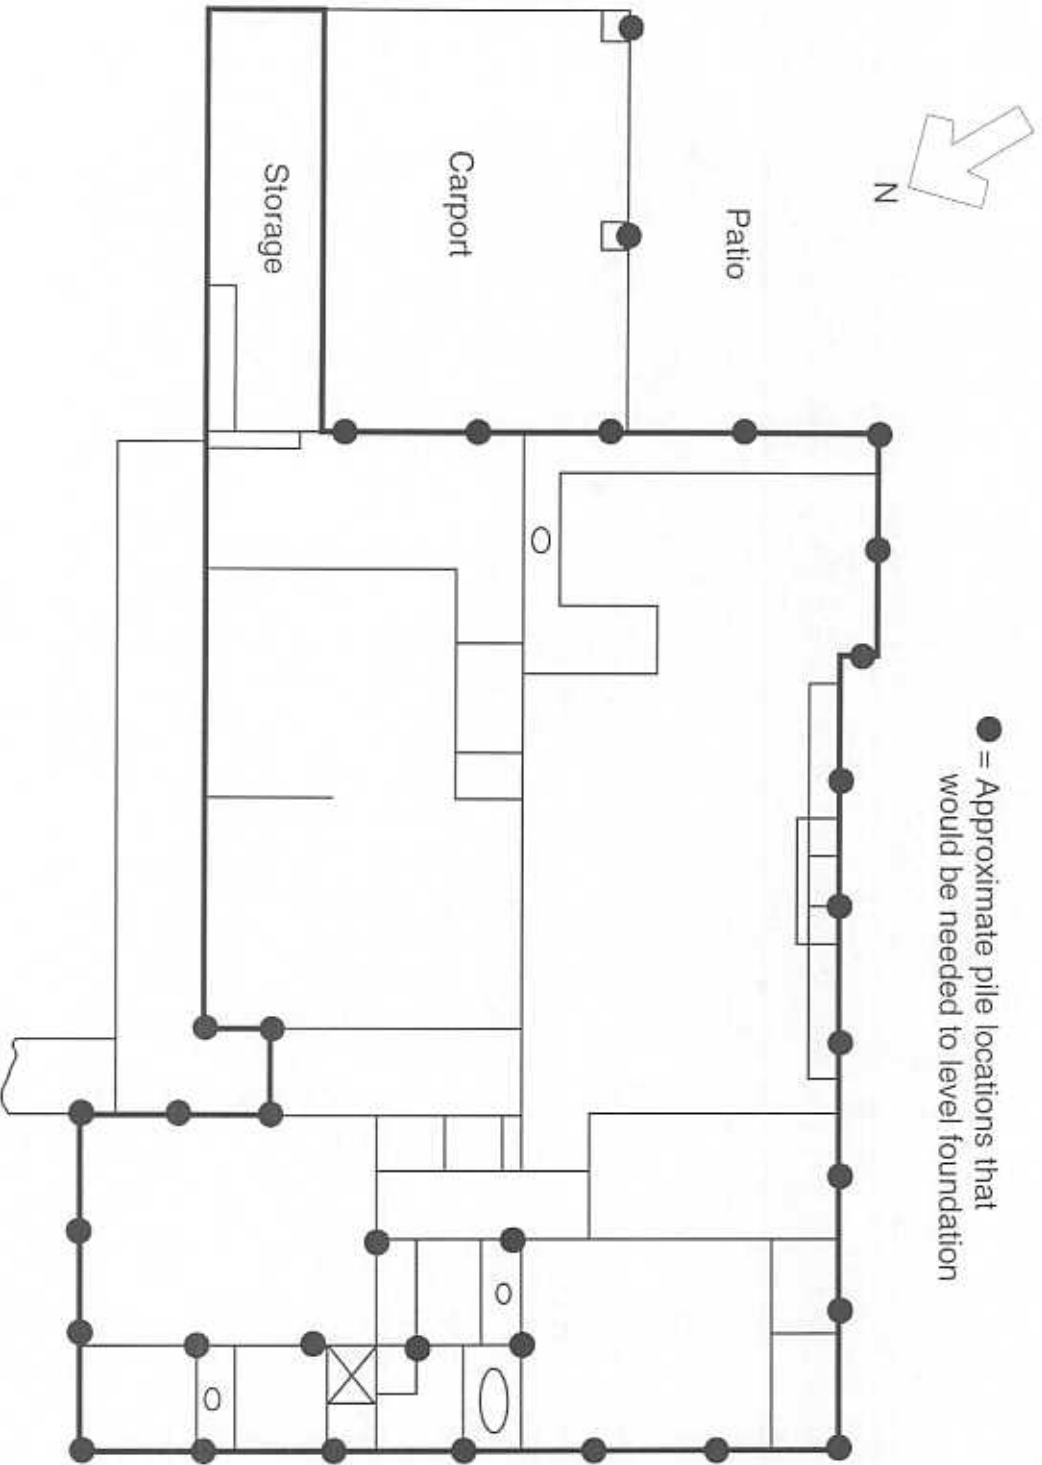
The drawing at the end of this report is provided to aid in determining the condition of the foundation. "R" on the drawing represents the reference point from which all other level readings are taken and it is arbitrary. Changes in floor coverings such as the transition from carpet to tile etc. are taken into consideration when taking level readings. Taking the largest positive reading and adding the largest negative reading will give the overall levelness of the structure. Generally, when new houses are finished, a certain amount of slope is built in. This slope is generally in the range of 1.5 inches for the average size house. Level readings are valuable not only as a diagnostic tool but can be used as a reference for any suspected foundation movement that may occur in the future. Readings can also verify the stability of a house. Please note that the scale of the drawings can change with faxing or copying of the original sketches.

In the event the client decides to carry out foundation repairs, the attached sketch shows a reasonable arrangement for the piles. It is suggested that interior piles, if any, be installed by means of tunneling to avoid additional damage to the foundation. That type of additional damage can sometimes limit the degree of levelness which can be obtained during the foundation repairs. If contractors feel they can adequately level the foundation by means of piles installed through the floor of the slab, that approach would be much cheaper. If rerouting of the underslab sewer lines is necessary in the bathroom area then coordination between the foundation repairs and the rerouting might be carried out to make use of the rerouting tunnels in order to install the pilings from underneath. A complete copy of the report should be given to any prospective contractor. This information may be used by the client for the process of obtaining bids for this work. The client may wish to resolve any significant differences between our suggestions and the recommendations made by the contractor. It is important to understand that this arrangement is based upon our engineering judgement; however, the warranty will be provided by the contractor who is solely responsible for the work and should, therefore, make the final selection. The degree of levelness to be expected from the foundation repairs should be discussed in advance with the contractor in order to avoid any misunderstandings. No foundation repair contracts or warranties with which I am familiar discuss the degree of levelness to be obtained during the repairs. We have found that most new houses of this size are level within about 1.5" and it should be possible in our opinion to level the house with the pile layout shown to within approximately that range, keeping in mind that other considerations come into play when trying to determine the original position of the house. After leveling, brick lines should be straight and approximately level. Other components of the house, such as door frames, window sills, counters, etc. should also be level after foundation repairs. Overlifting in an attempt to close cracks should be avoided since debris in them can sometimes prevent them from closing. Additional sheetrock cracks can be expected as a result of this operation. It is important that any void space created by foundation leveling not be filled in order that foundation heave will not result from future changes in soil moisture. This would not apply to any void created by sewer leaks. It is recommended that another foundation inspection be carried out after the leveling, both in order to verify their adequacy and in order to give an independent set of level readings to the client for warranty purposed with the contractor. In any case, neither the author nor Sealy Engineering assumes any responsibility whatsoever for the results of the work of the contractor.

● = Approximate pile locations that would be needed to level foundation
